The Church of the Nativity

By Nazmi al-Jubeh

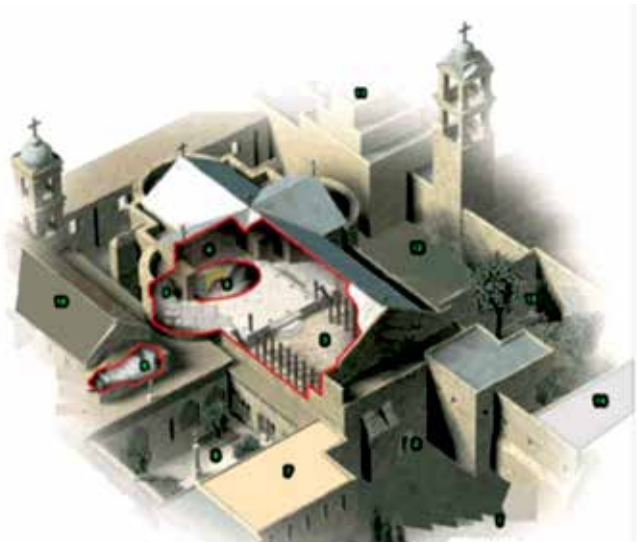
Church of Nativity Compound

The numbers in image are: 1. Nativity Square (to Manger Square); 2. Gate of Humility; 3. The Nave; 4. High Altar and Greek Orthodox Basilica (iconostasis); 5. Stairs to Grotto; 6. Grotto of the Nativity – A Silver Star marks the spot where Jesus Christ is believed to have been born; 7. Franciscan Monastery; 8. Franciscan Courtyard; 9. Grotto of St. Jerome; 10. St. Catherine's Church; 11. Greek Orthodox Monastery; 12. Greek Orthodox Courtyard; 13. Armenian Courtyard; 14. Armenian Convent.

A model of the Church of the Nativity complex, the basilica in the middle; on the left, St. Catherine Church and Franciscan Monastery; on the right, the Armenian Monastery.
